Fractographic Inspection of the
Cracking FT488/2 Removed at
Program 79

DSTO-TN-0170

**Airframes and Engines Division
Aeronautical and Maritime Research Laboratory**

During the inspection of the FT488/2 Bare Bulkhead Fatigue Test specimen after 79 blocks of applied loading, cracking was found in several wing-attachment hole aft edges. Each of the cracked regions of the holes was cut from the bulkhead, sixteen of the cracks were broken open and the exposed crack surfaces were analysed. This analysis revealed several interesting aspects of fatigue crack growth in this bulkhead. These included the nature of the most (in this case) significant initiating flaws, the type (compared to other thick 7050 plate material) and effect of the microstructure on the growth of these cracks, and the relative growth rates of these cracks including estimates of the number of programs to failure.

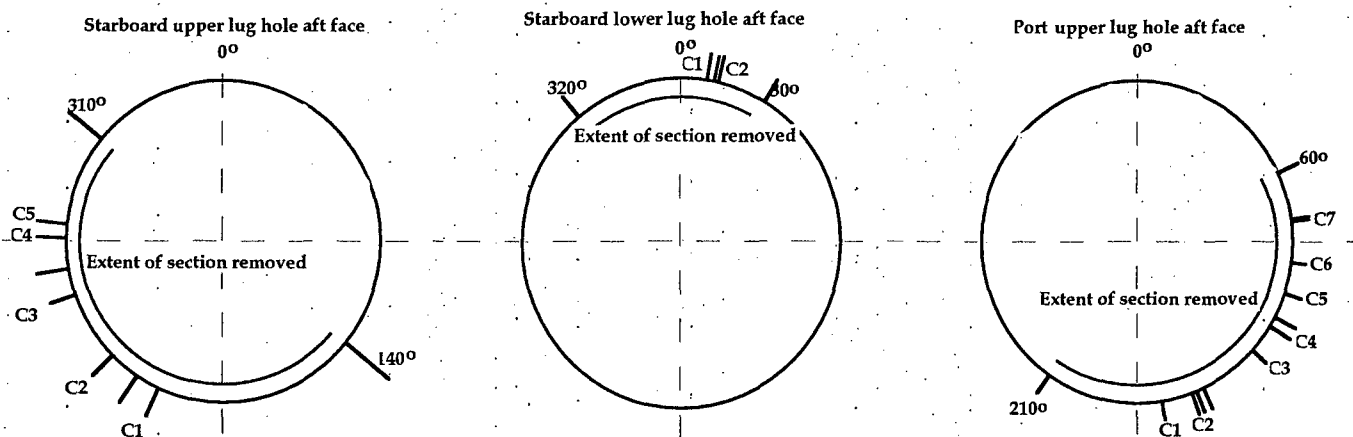
Figure 3. A schematic diagram of the approximate positions of the observed cracks in the edge of the wing-attachment holes. The red line indicates the region of material removal. The cracks that were opened and examined by fractography are marked 'C1, C2, etc'.

During the examination of the removed sections, and the cracks that were contained in them, it was noticed that in all three pieces removed from the wing-attachment holes a ridge existed close to the edge, on the hole surface. This ridge, in each case, was a short distance from the outer edge of the holes. (An example of this ridge is shown in Figure 2A). In all cases, the cracking was confined to the region between the edge of the hole and the ridge. This ridge appears to have been caused by the edge of the copper alloy bushes, which were fitted to these holes, not extending to the outer edge. This meant that when the copper alloy bushes were cold-expanded their edge formed a ridge in the hole surface.

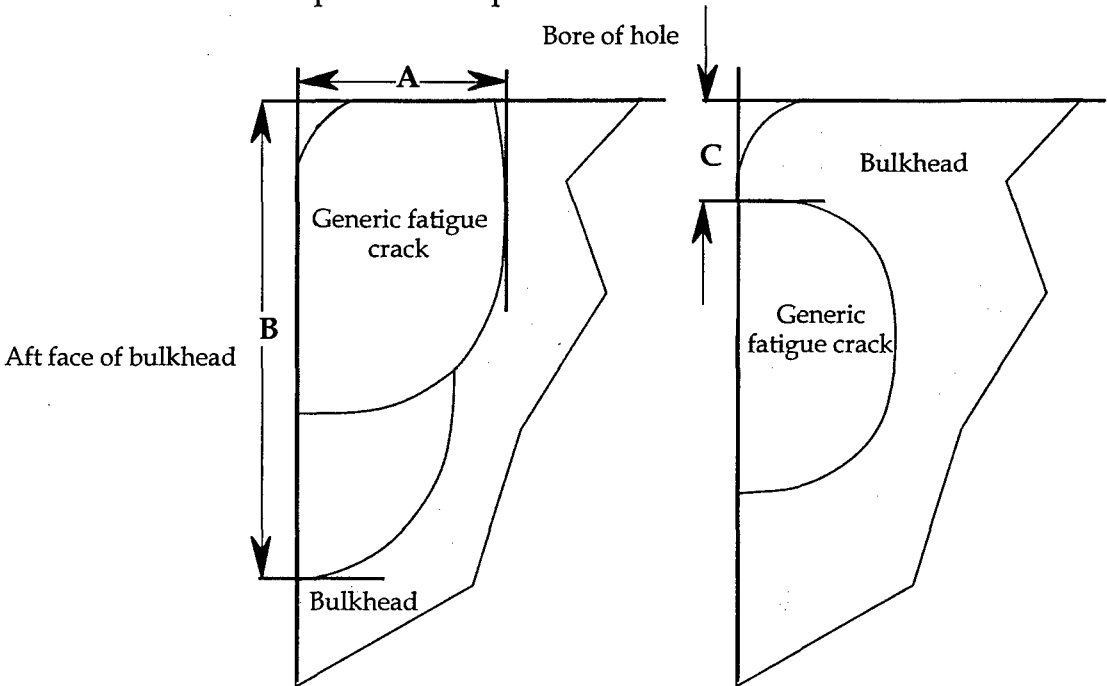
Figure 4. Schematics of the fatigue crack types showing the positions of the dimensions presented in Table 1

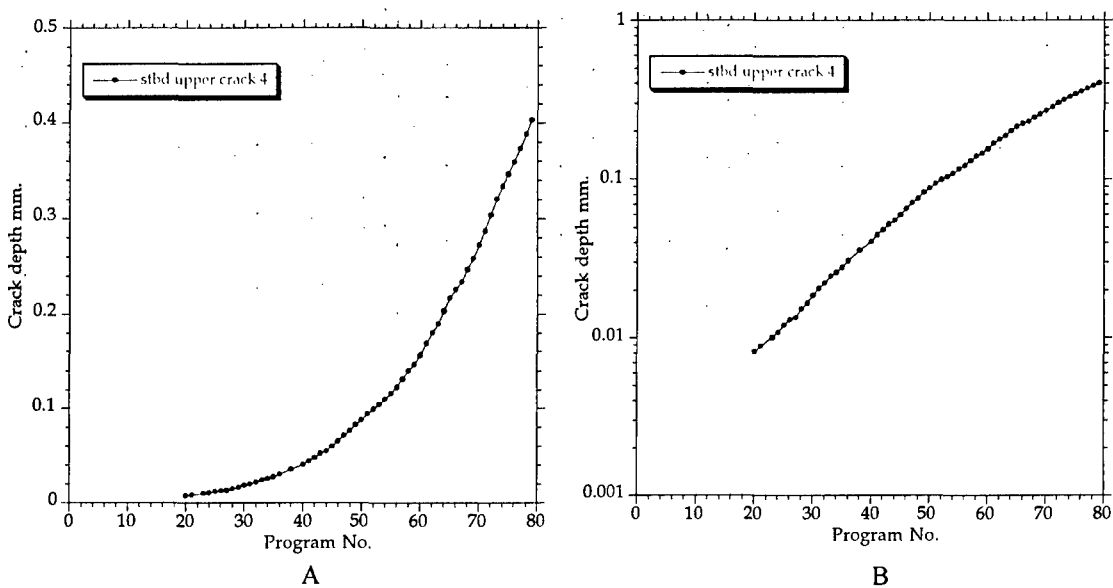
In this case, the main crack origin occurred some distance from the wing-attachment-hole. The crack grew with a 'thumbnail' shape and remained independent of the wing-attachment hole for a large part of its life. The actual originating flaw had been removed by polishing during the test. The crack is shown in Figure 11A, while view B shows a close up of the region from which the fractography measurements were started.

Figure 12. Two plots showing the results of quantitative fractography. Plot A – linear crack depth versus Program No. and B - crack depth on a Log scale versus linear Program No.

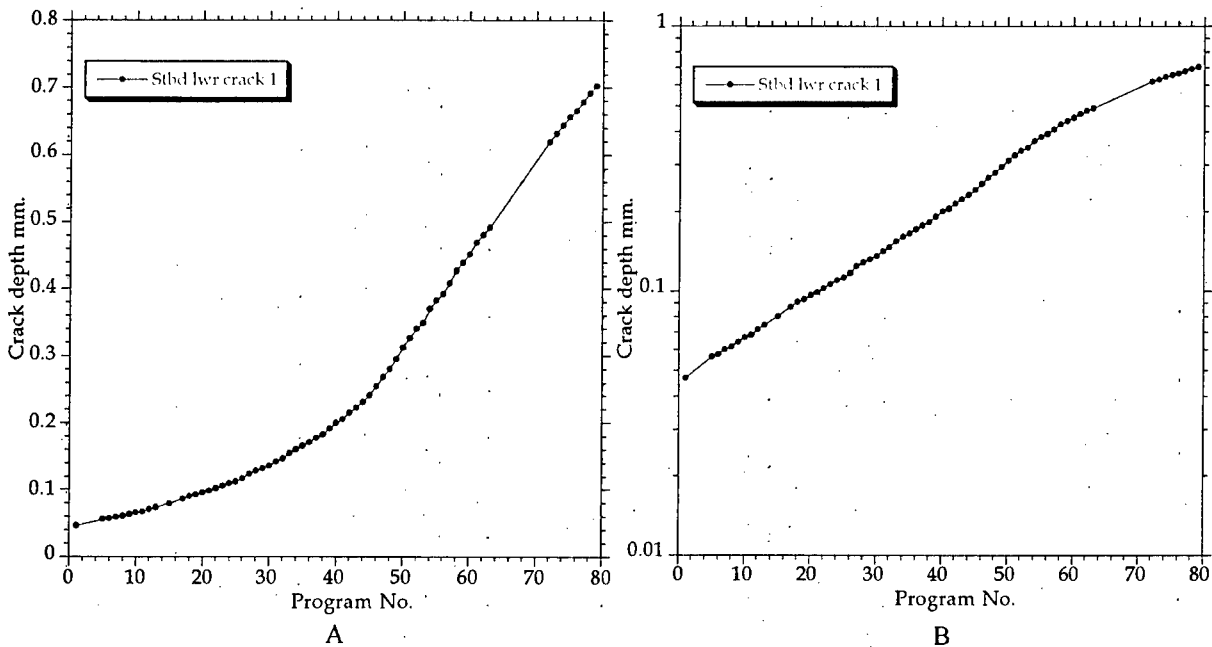
Quantitative fractographic examination gave the results as set out in Figure 17. The nature of the lip precluded estimating the flaw size, although an examination of the growth as depicted by the fractography indicates that the 'effective initial crack' size was about $45\mu\text{m}$. Although it is possible that the damage, and therefore the crack initiation, occurred some time after the start of the test, the fractography suggest that it occurred very early, if not at the start of the test. Some residual stress effect may have been present as evidenced by the slight change in the slope of 'B' in Figure 17, although this effect must have been small.

Figure 17. Two plots showing the results of quantitative fractography on crack 1. Plot A – linear crack depth versus Program No. and B – crack depth on a Log scale versus linear Program No.

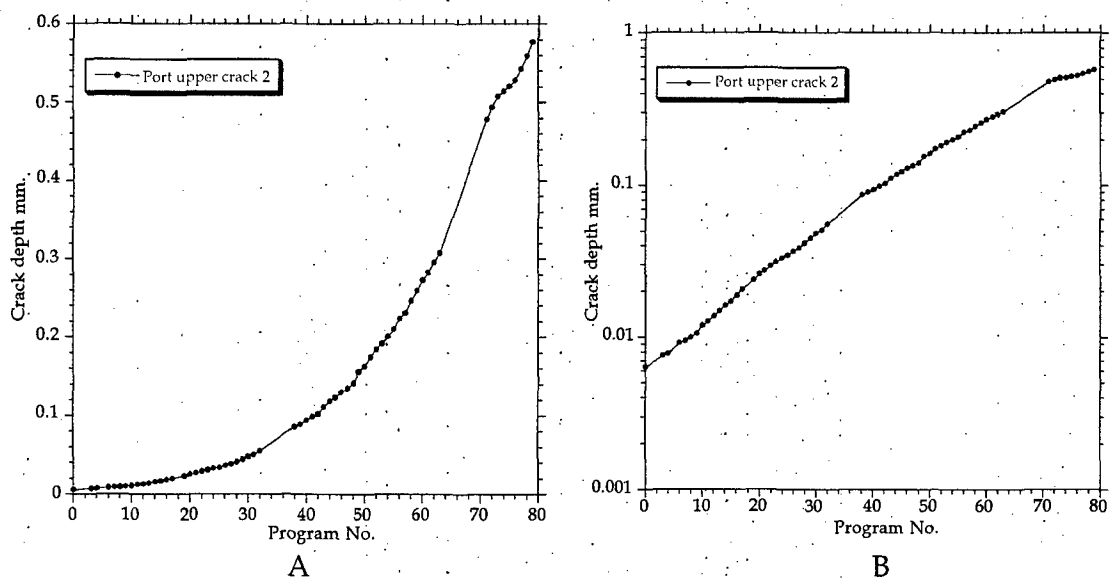
This crack originated from multiple sites beneath the intact IVD coating on the aft face of the bulkhead. These sites were spread over about a 0.5mm length centred about 0.5mm from the hole edge. The numerous cracks joined to form a single crack front, Figure 21A. Small etch-pits, probably associated with grain boundaries, acted as the initiating flaws. Intersection with the wing-attachment hole probably occurred relatively late in the crack growth life - at a crack depth of about 200µm.

Figure 22. Two plots showing the results of quantitative fractography. Plot A - linear crack depth versus Program No. and B - crack depth on a Log scale versus linear Program No.

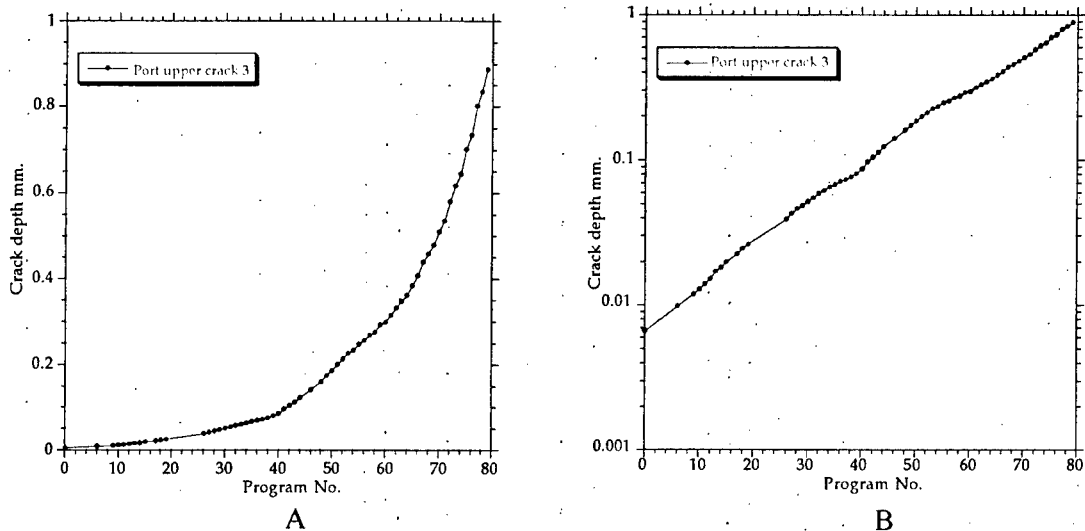
This crack originated from multiple origins beneath the IVD coating on the aft face of the bulkhead. The origins were closely spaced, centred at a distance of about $750\mu\text{m}$ from the hole edge, Figure 23A. Small etch-pits, probably associated with grain boundaries, acted as the initiating flaws. The crack's main initiation appears to have been associated with a grain boundary - the crack followed this boundary during its very early growth, view B. Intersection with the wing-attachment-hole occurred late in the crack growth life - at a crack depth of about $300\mu\text{m}$.

Figure 24. Two plots showing the results of quantitative fractography. Plot A - linear crack depth versus Program No. and B - crack depth on a Log scale versus linear Program No.

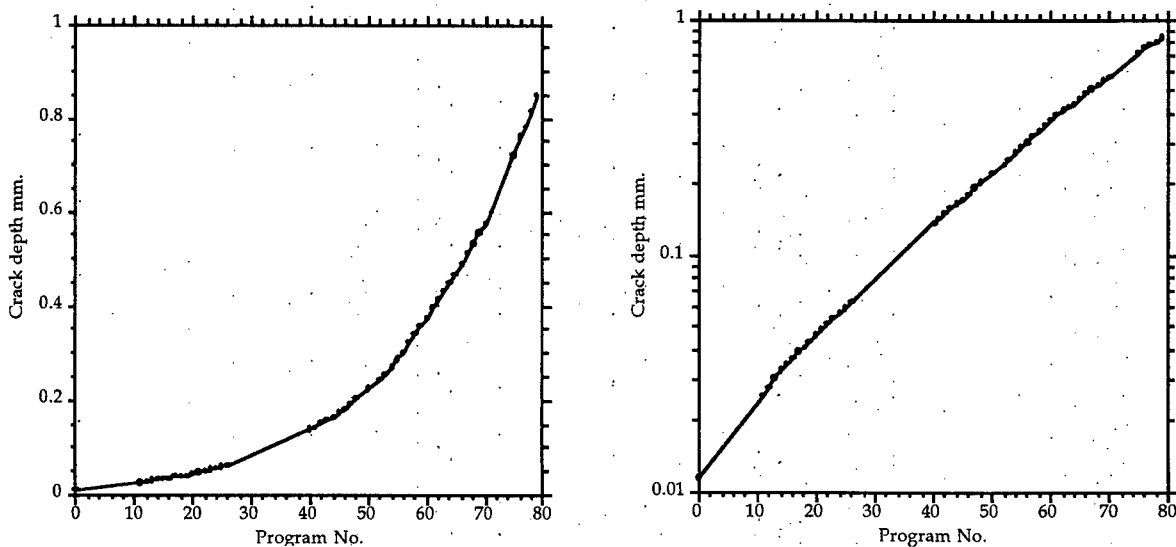
This crack originated from multiple sites beneath the intact IVD coating on the aft face of the bulkhead. The crack grew forward into the bulkhead. The initiation sites were spread over about a 0.1mm length centred about 0.4mm from the hole edge. The numerous cracks joined to form a single crack front, Figure 25 view A. Small etch-pits, probably associated with grain boundaries, acted as the initiating flaws. Intersection with the wing-attachment hole probably occurred relatively late in the crack growth life - at a crack depth of about 300µm.

Figure 26. Two plots showing the results of quantitative fractography of crack 4. Plot A - linear crack depth versus Program No. and B - crack depth on a Log scale versus linear Program No.

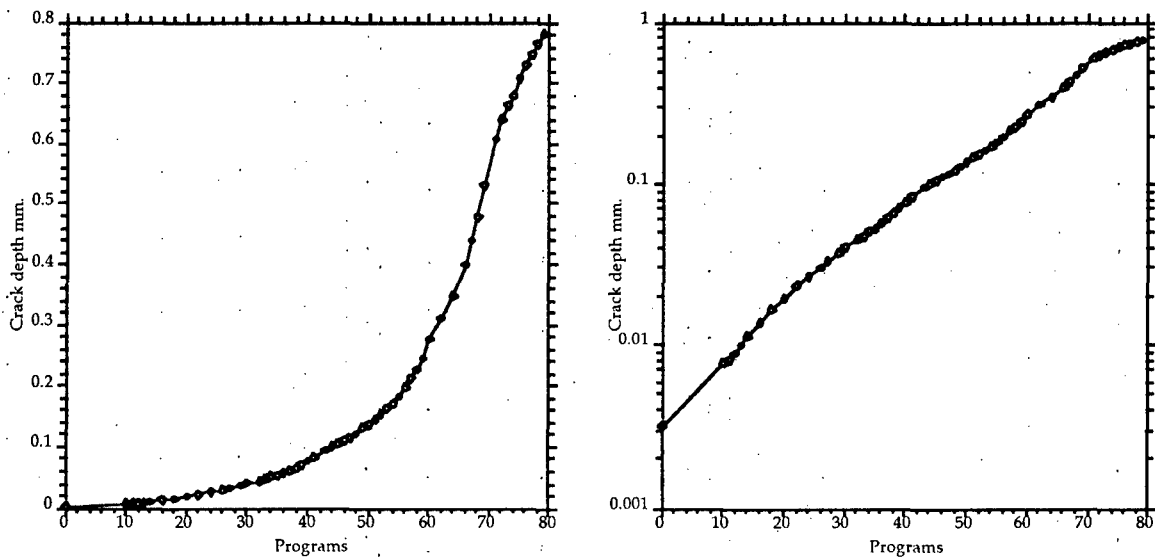
This crack originated from multiple sites beneath the intact IVD coating on the aft face of the bulkhead. A single main area of initiation was observed which had several closely spaced origins. These joined to form a single crack front, Figure 27A. Small etch-pits, probably associated with grain boundaries, acted as the initiating flaws. The crack grew with a 'thumbnail' shape, intersecting the hole relatively late in the crack's life - at a crack depth of about 150µm.

Figure 28. Two plots showing the results of quantitative fractography. Plot A - linear crack depth versus Program No. and B - crack depth on a Log scale versus linear Program No.

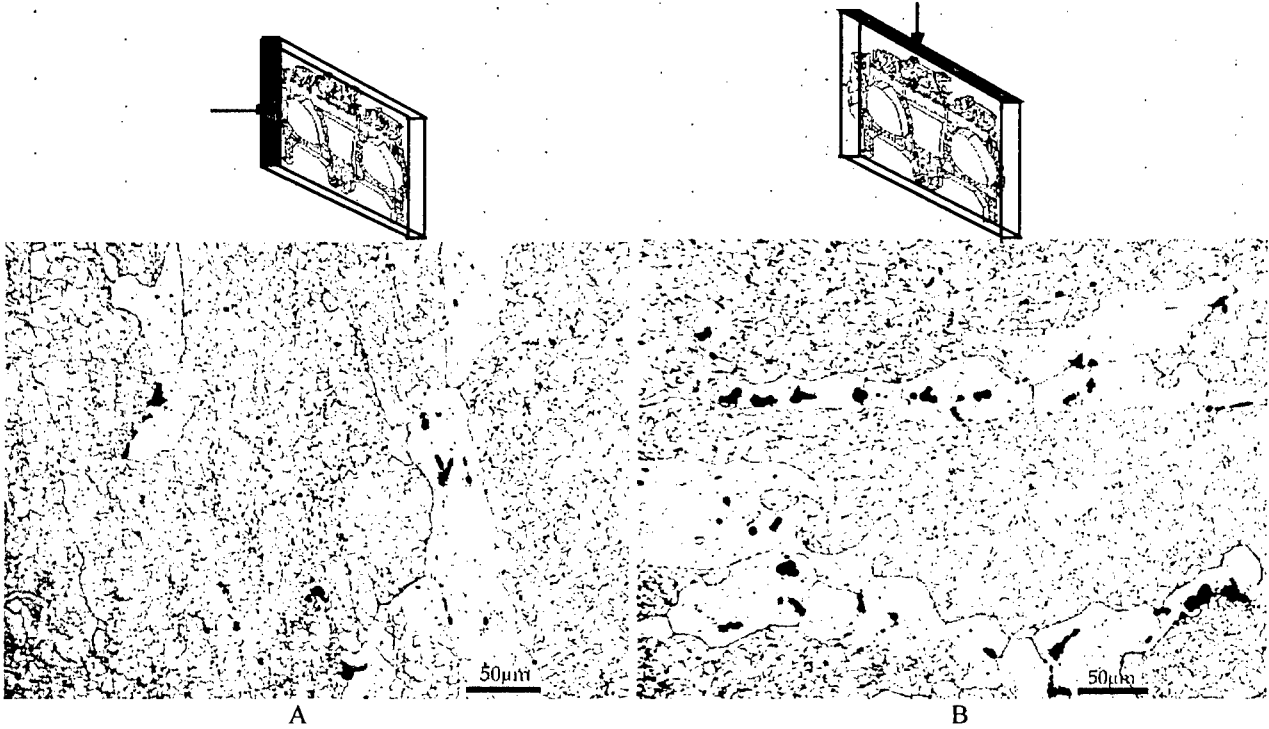
Several sections were cut from the pieces removed from the edges of the wing-attachment holes. These cuts were adjacent to the cracking. Examples of two of the sections are shown in Figure 34 A & B. These views were cut at right angles (A is looking at the plate edge and B is looking at the plate end). The general microstructure revealed was fine grained (average grain size about $10\mu\text{m}$) with larger, elongated grains (50 to $100\mu\text{m}$). On a larger scale the fine grain material tends to form islands surrounded by the coarse grained material. Many large inclusions were visible although they were mostly elongated or broken up, rather than 'Y' shaped (from solidification) as has been observed with 7050 plate of poorer quality [2]. The structure revealed was produced during re-crystallisation, which can, apart from other sites in the material, initiate at inclusions. As the largest inclusions are usually associated with the largest grains it is probable that these inclusions initiated grain growth during re-crystallisation either faster or earlier than the other initiation sites, leading to excessive grain growth for those grains associated with the large

inclusions. This is consistent with the inner part of the plate having more large grains, due to the longer time that this region has to cool from the re-crystallisation temperature

Figure 34 The general microstructure of two sections through the port upper aft sliver. Note that these sections show the duplex grain size and the massive inclusions associated with the large grains.

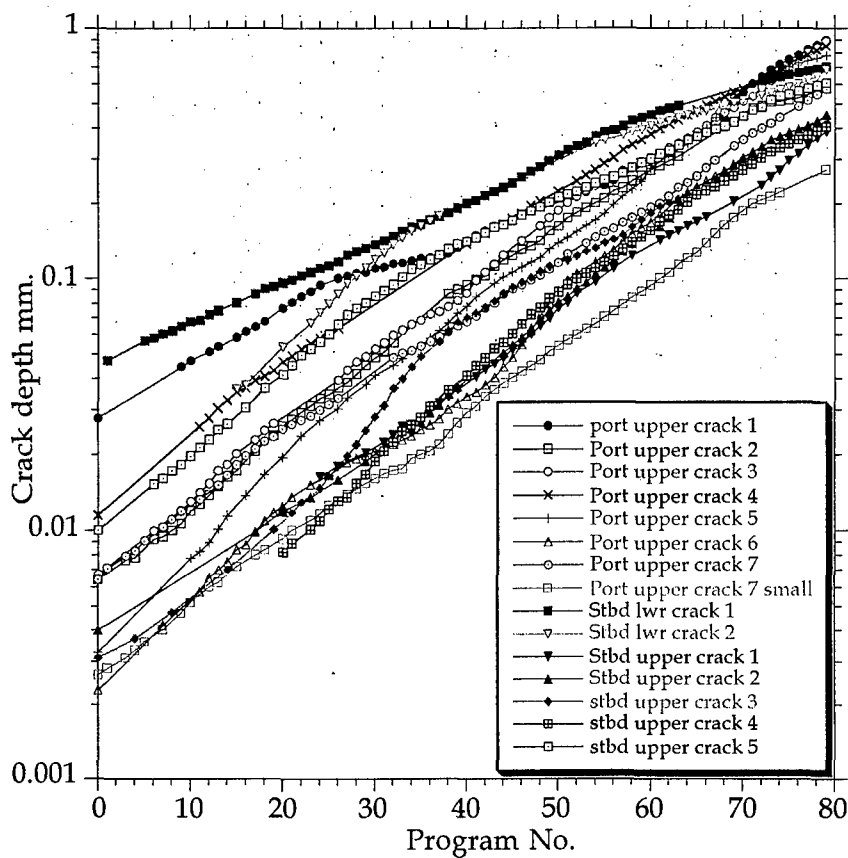
The fractography results were combined and are presented in Figures 44 and 45. Curve fitting each of the data sets using the formula

gave a measure of the severity of the stressing for each crack position. The severity is indicated by the slope of the curve or 'b', while 'a₀' indicates the projected 'effective initial crack' size, which may differ from the measured initial flaw size. If the crack growth has a significant amount of linear growth on the log/lin presentation, then the 'b' constant will be a good measure of the likely growth rate in that position, regardless of the type or size of the initiating flaw. In fact, 'b' may be a material constant for a particular spectrum - combining the growth resistance factors which apply to the material. Interestingly the microstructural orientation did not appear to have a significant effect on these results. This leads to the notion that in order to estimate the life of a bulkhead area, both the 'a₀' (initial flaw size) and 'b' (stressing) must be known. Unfortunately the growth data produced to support life estimation is typically a combination of the initial flaw size and the growth to failure, with the final part of this growth distorted by tearing events. This results in difficulties if laboratory specimens do not adequately match the service component; there are significant differences in the initial flaws expected in carefully prepared laboratory specimens, made from material that may be non representative of service components. For instance most of the upper hole fatigue cracks initiated from flaws created by a combination of the IVD etching treatment and the microstructure of the 7050 plate, whereas initiation in laboratory specimens are nearly always found to occur at inclusions or mechanical damage (machining marks). It is noteworthy that inclusions did not initiate the cracking in the upper holes, and that there was evidence that inclusions could arrest very short cracks in these regions, given the large number of cycles that the bulkhead has recieved. Clearly, these differences along with a requirement to produce failures, in laboratory specimens, within a reasonable time, could result in the stressing of laboratory tests being higher than that required to produce the same cracking in the full-scale bulkhead.

Figure 45. All of the crack growth curves plotted on the same axis- log/lin.
